PHASE I ENVIRONMENTAL SITE ASSESSMENT

Berks County Industrial Development Authority (BCIDA) Airport Tract: Lot 1 and Aviation Boulevard Corridor Bern Township, Berks County, Pennsylvania

**Liberty Project No. 130432.02
April 20, 2015**

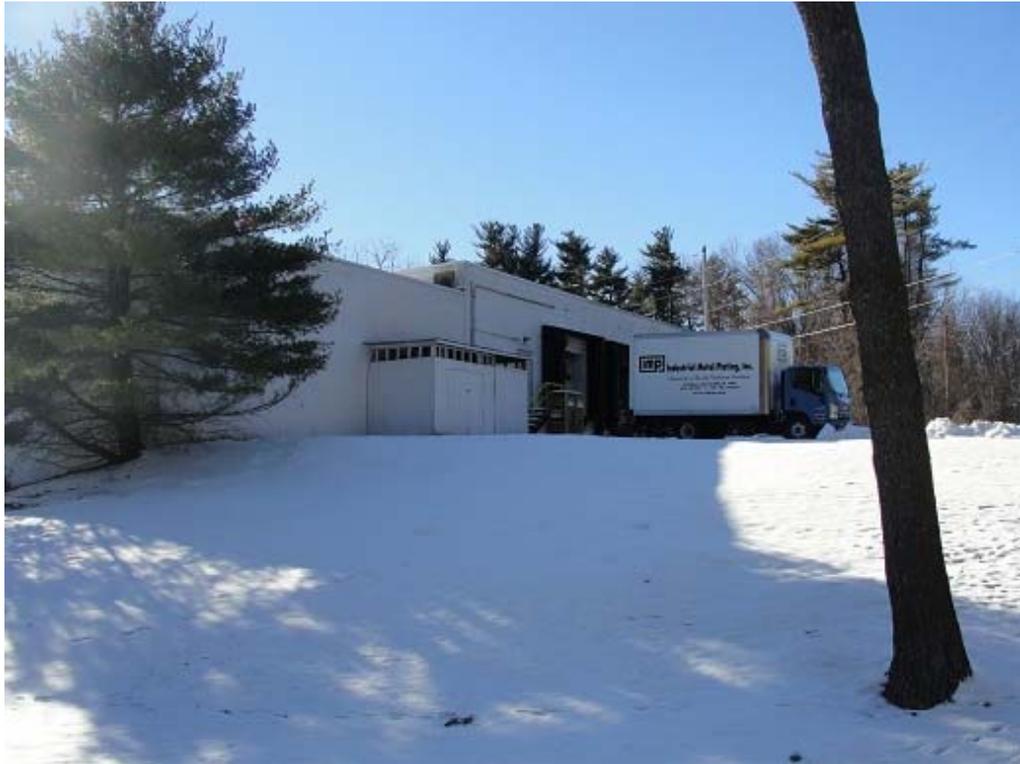
Photo 1: Exterior of the Industrial Metal Plating facility on the southern portion of the site, from Aviation Boulevard looking north.

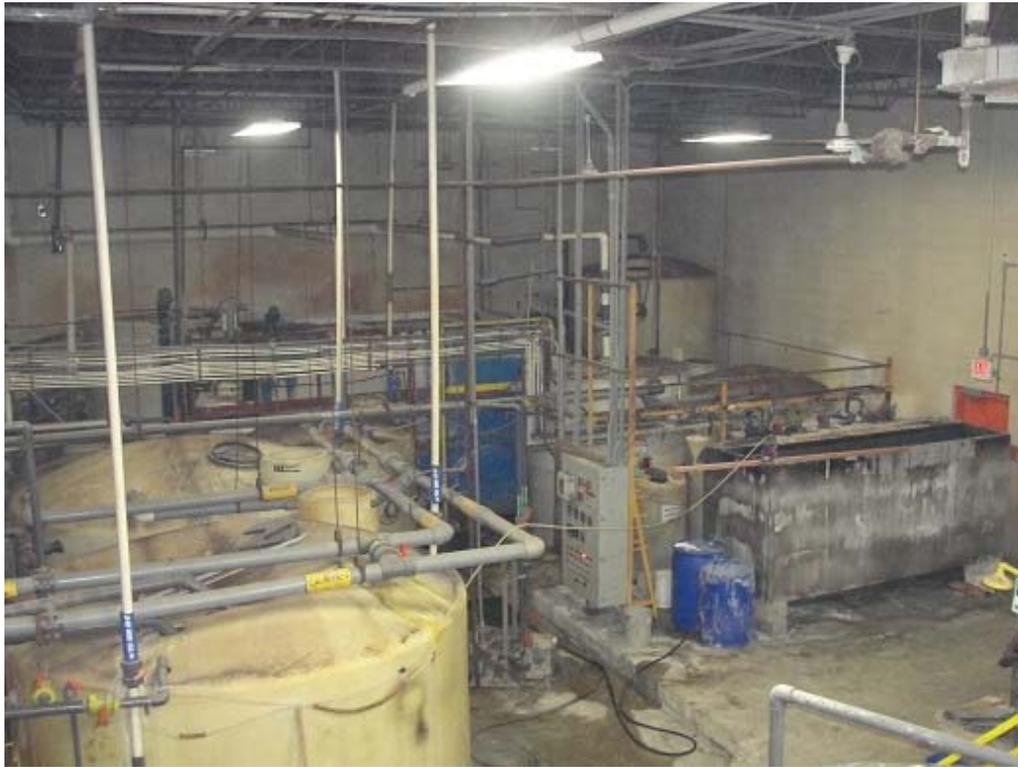
Photo 2: Interior of a process fluids room within the Industrial Metal Plating facility.

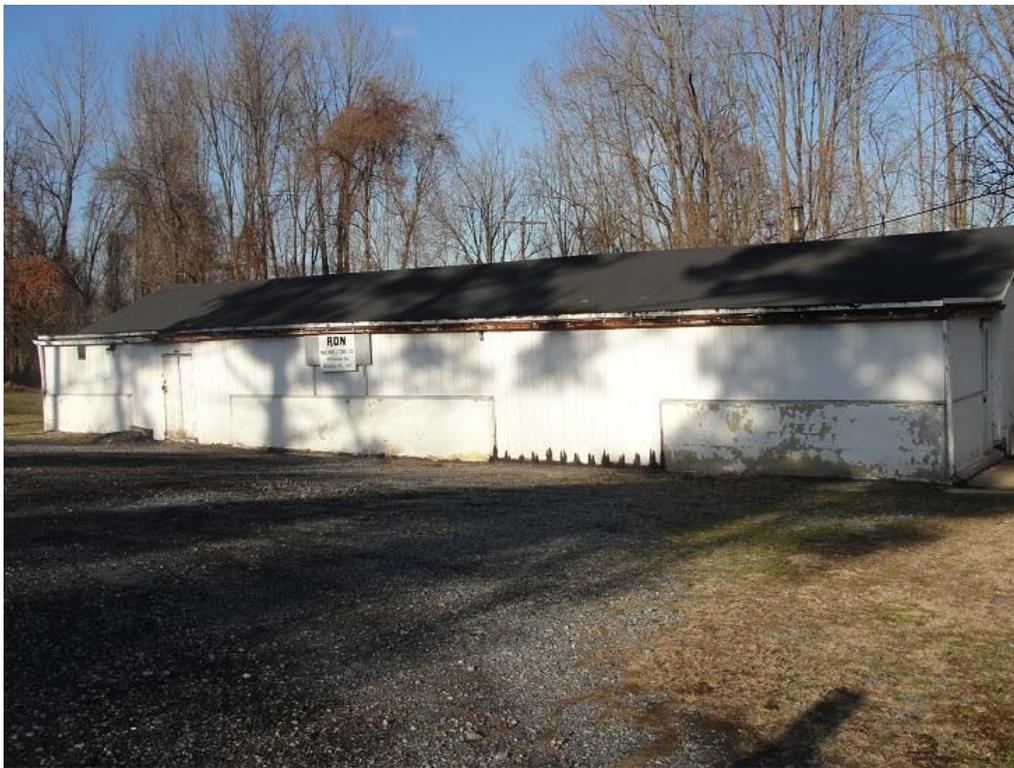
Photo 3: Exterior of the Ron Machine Shop building on the central portion of the site.

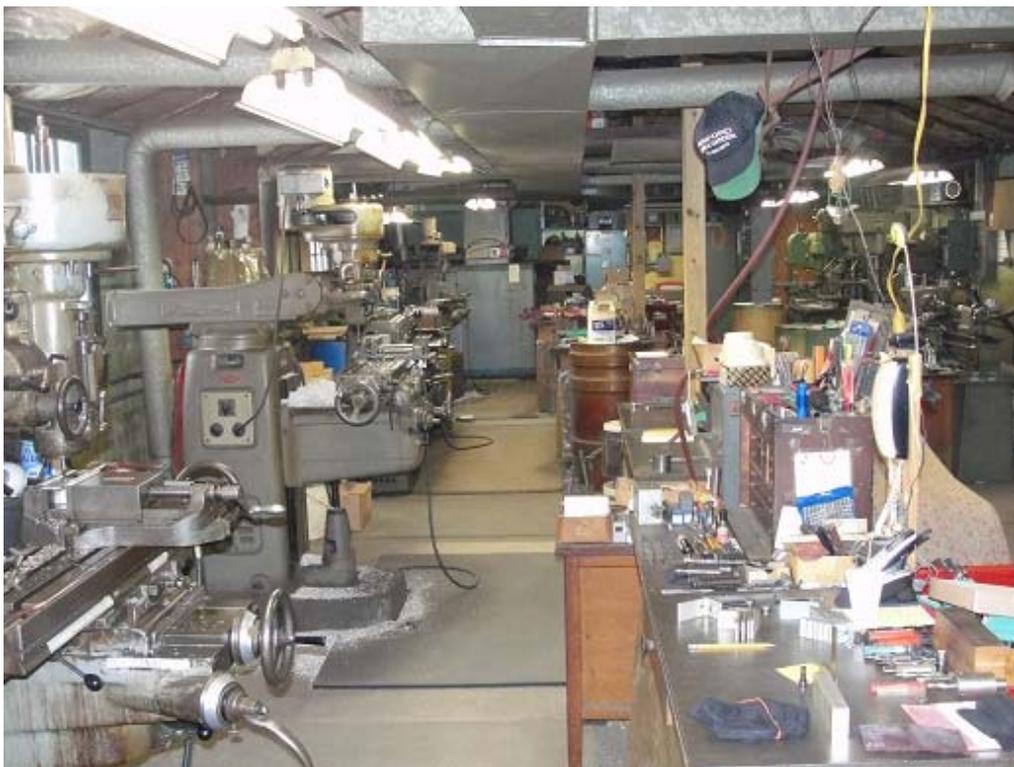
Photo 4: Interior of the Ron Machine Shop building, showing various machining tools and equipment.

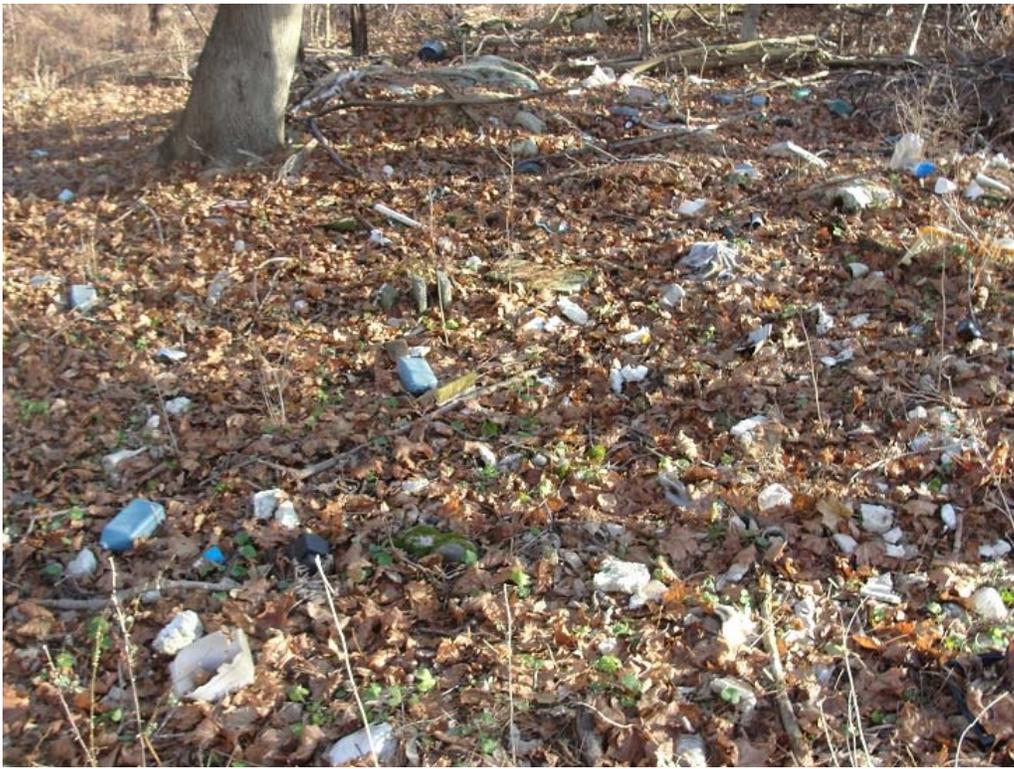
Photo 5: Typical scattered trash and debris in the clearings and along the roads of the former military base area in the center of the subject property.

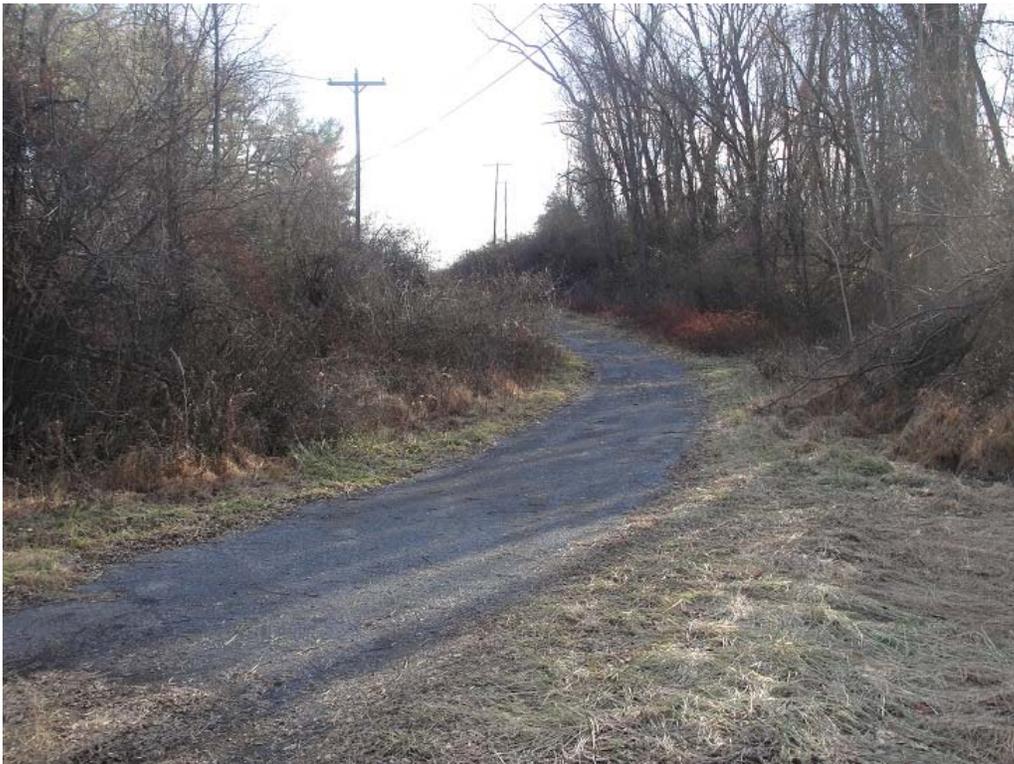
Photo 6: Unused road within the former military base area on the center of the subject property.

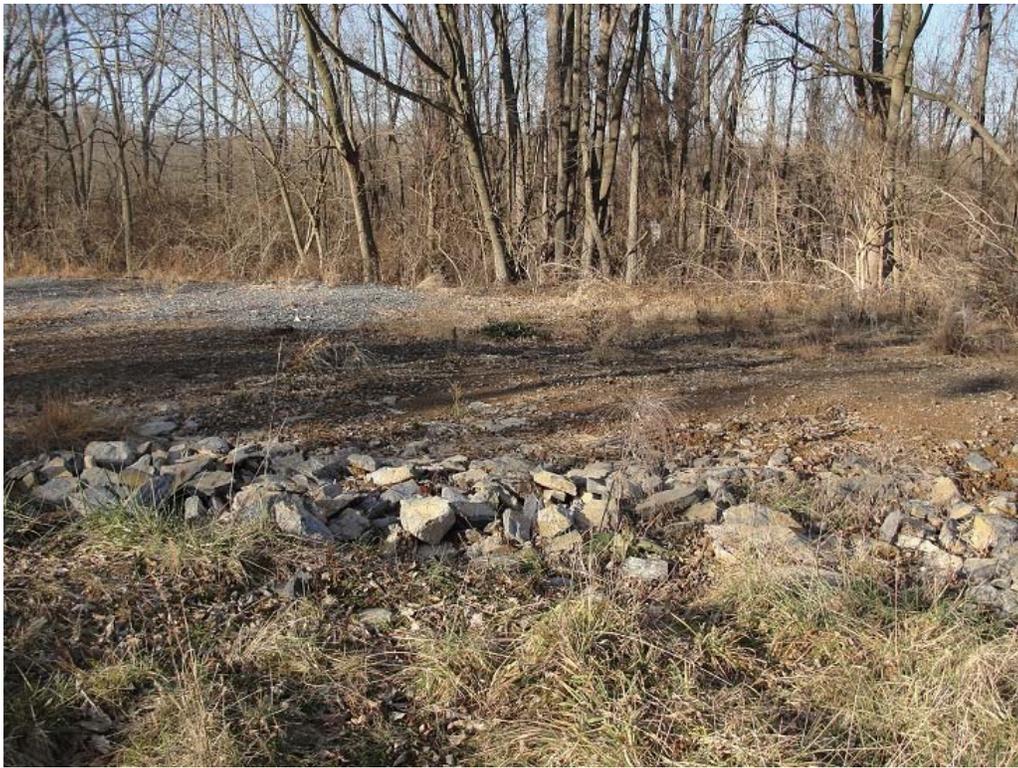
Photo 7: Typical former building clearing, with scattered building debris within the former military base area on the center of the subject property.

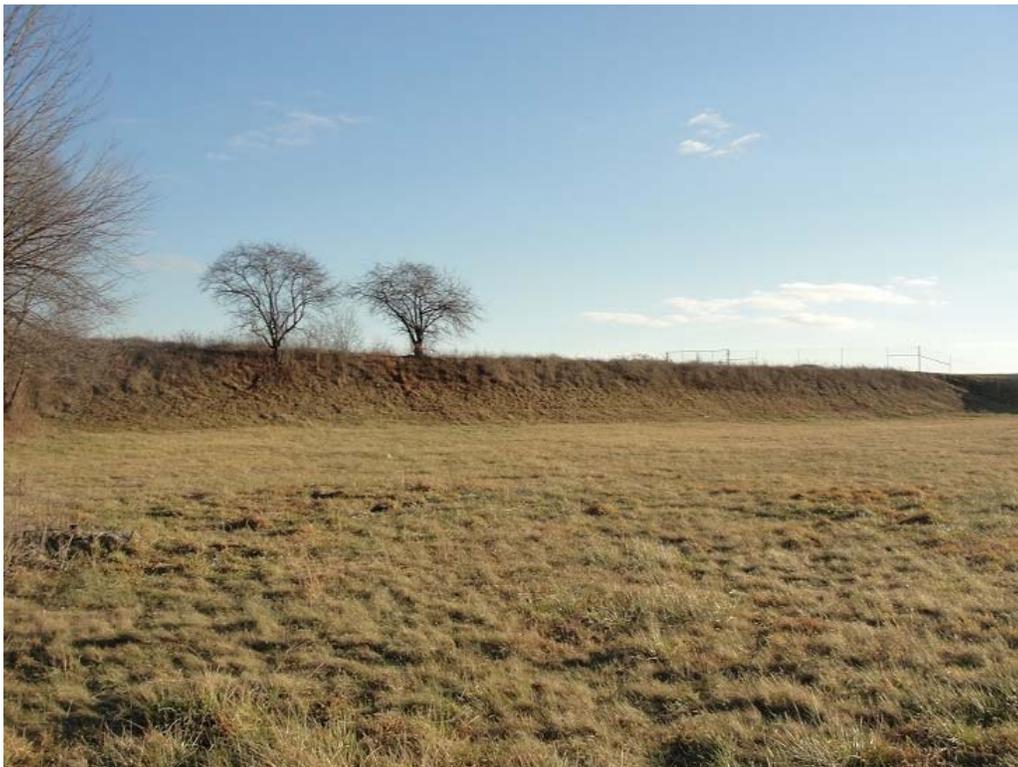
Photo 8: Cleared and graded area on the western portion of the subject property, adjacent to the Reading Regional Airport runway.

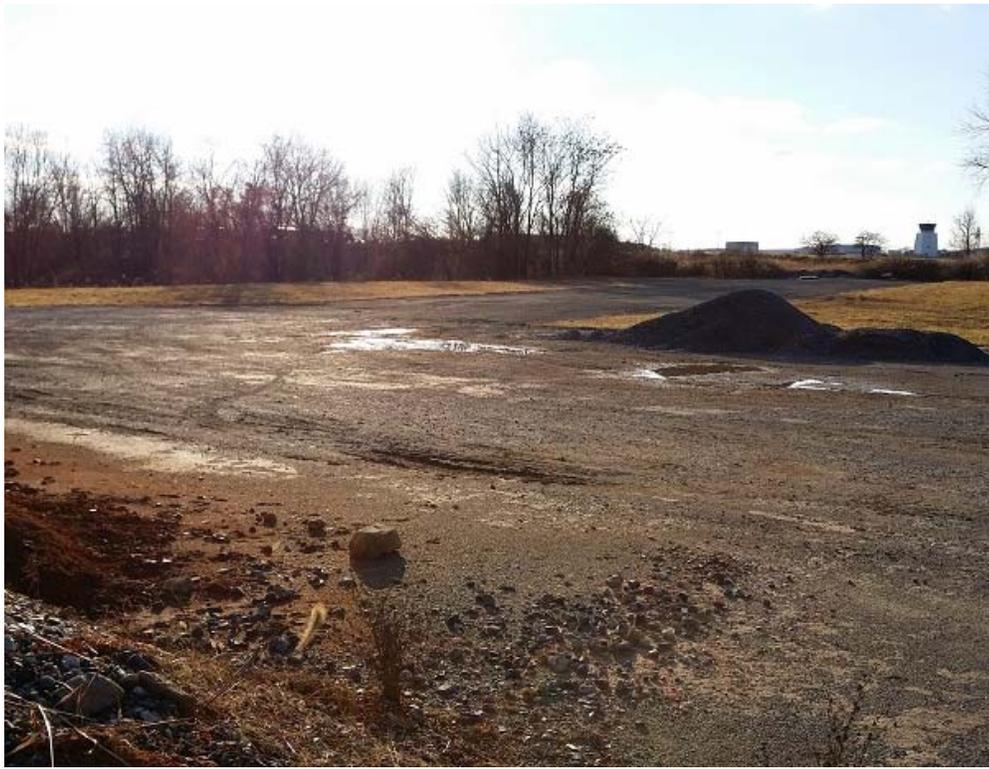
Photo 9: Former taxiway leading to the staging pad and firing bunker ('shooting-in butt') on the western portion of the subject property.

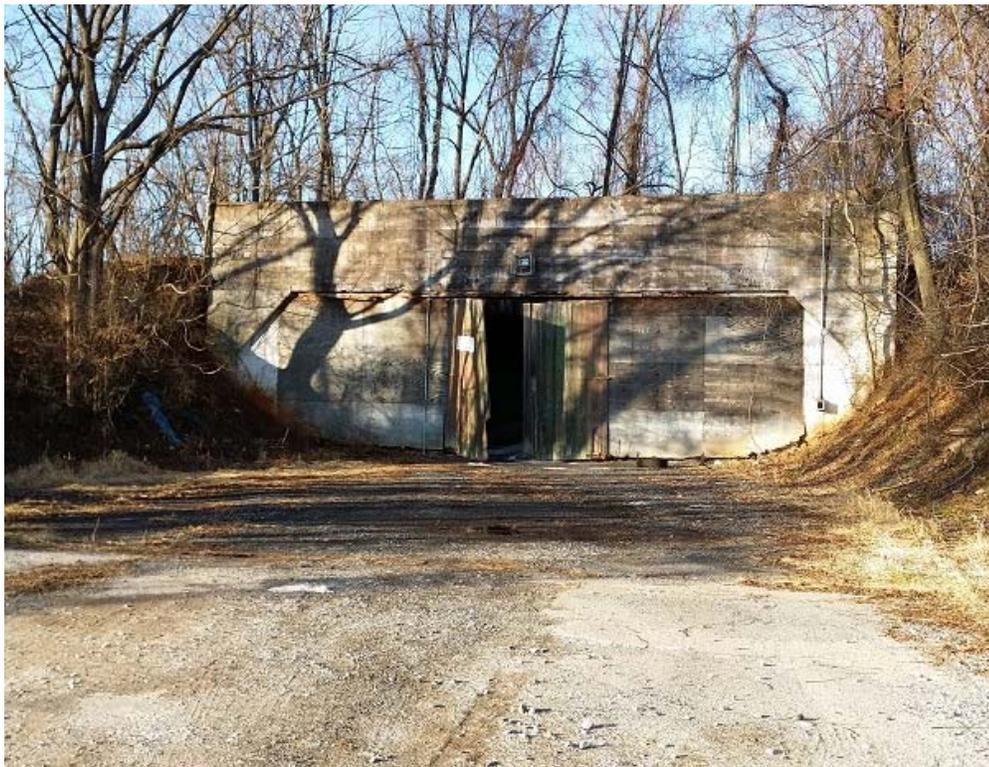
Photo 10: Former firing bunker ('shooting-in butt') located adjacent to the taxiway on the western portion of the subject property.

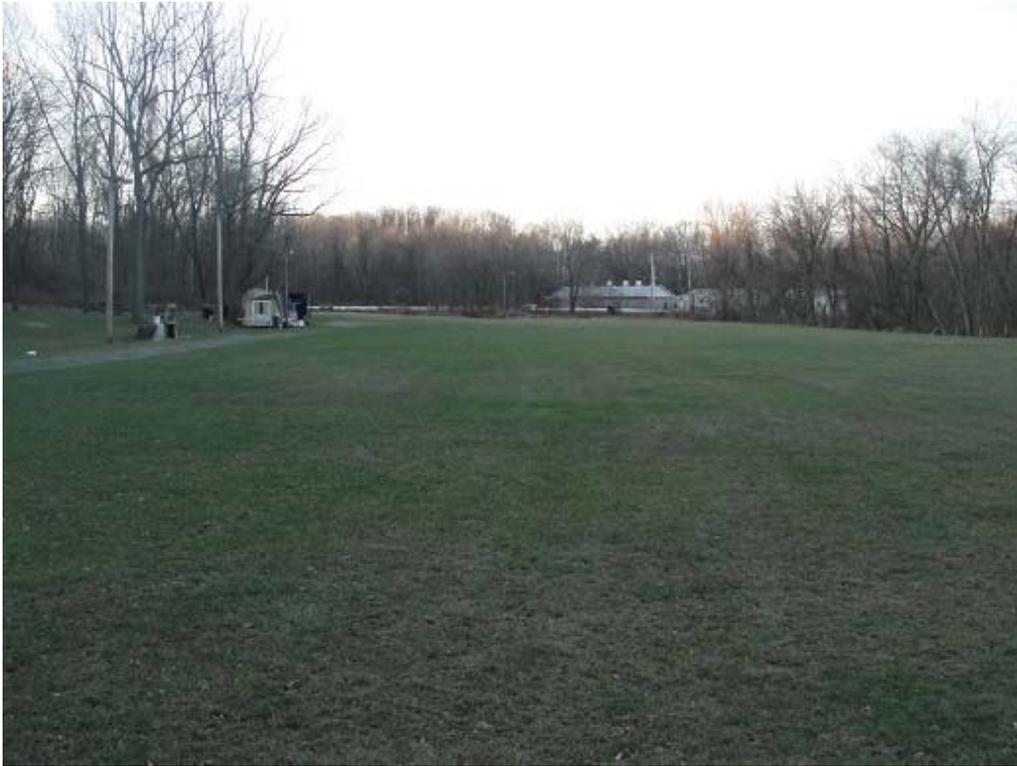
Photo 11: Cleared marching band practice field on the eastern portion of the site, adjacent to Aviation Boulevard.

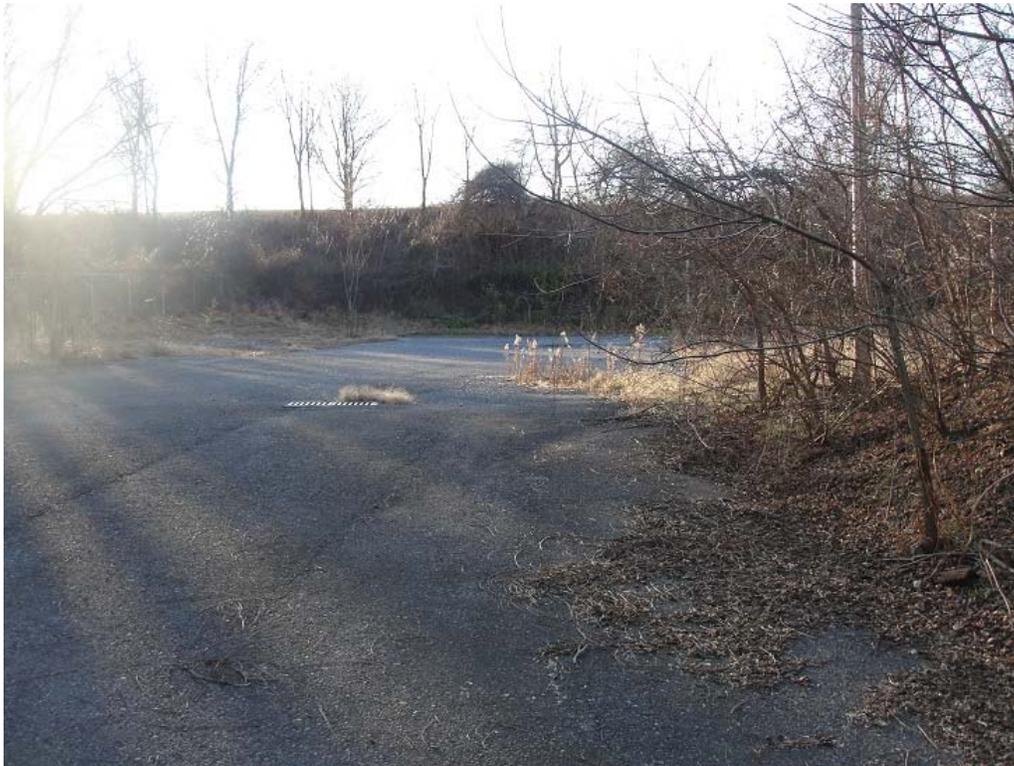
Photo 12: Former Reading/Berks County Police pistol range on the northern portion of the property.

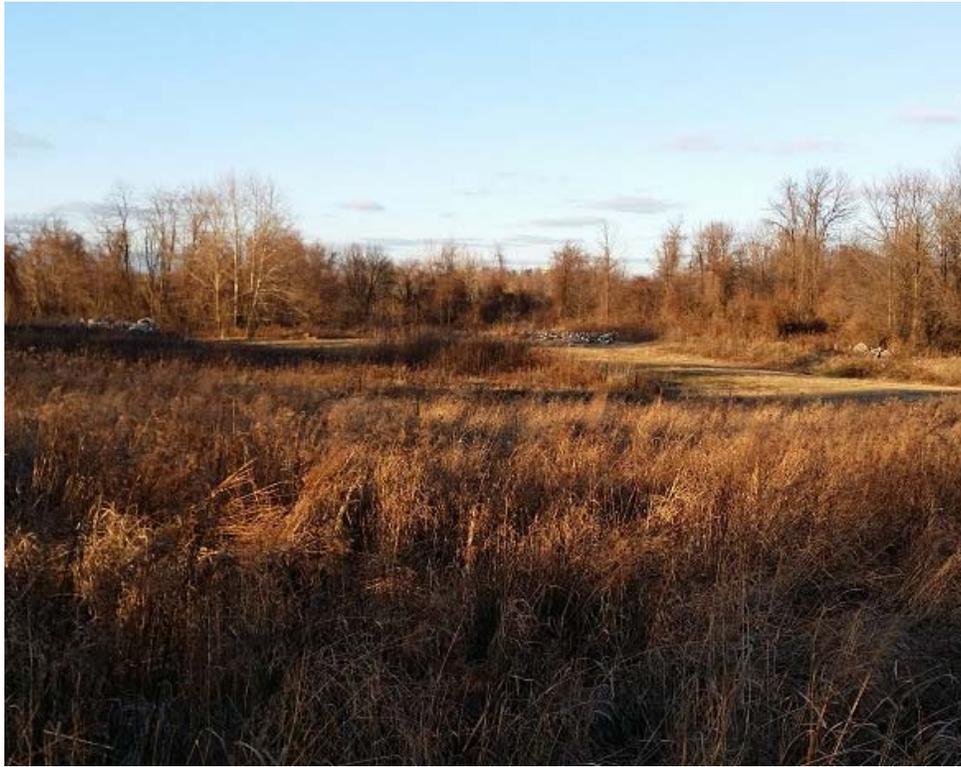
Photo 13: Large clearing (former soil stockpile area) on the northwestern portion of the property, adjacent to the Reading Regional Airport runway.

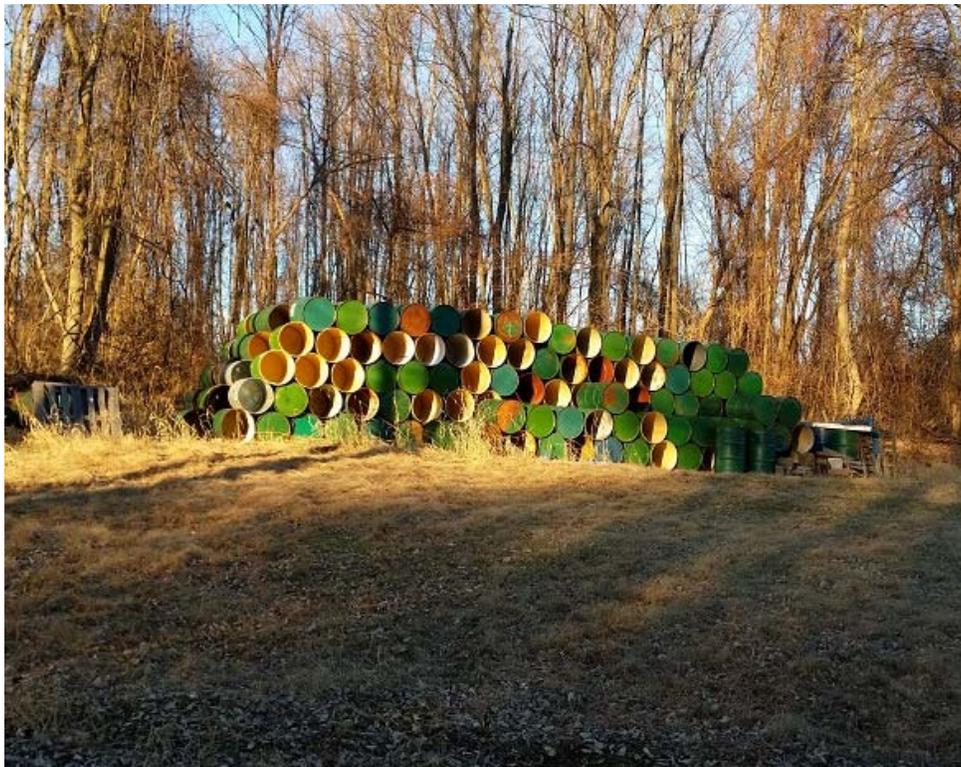
Photo 14: Metal 55-gallon drums (former fruit juice drums used as trash cans) stacked along an access path near the northwest clearing.

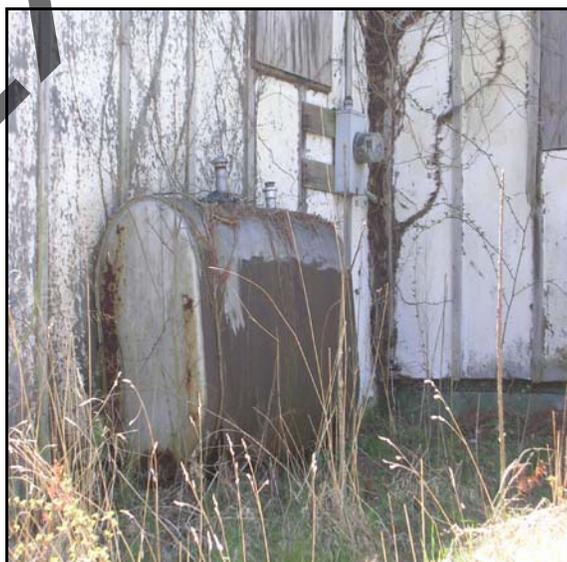
Building 123 AST.

- According to personnel interviewed, one 10,000-gallon heating oil UST is located on the west side of the IMP facility. No history of spills or leaks is associated with this UST.
- One 275-gallon heating oil AST is currently used at Building 130. The tank was in poor condition (corroded), however no soil staining, odors, or stressed vegetation were observed near the tank. Correspondence with the building tenant (Ron's Machine) revealed that no history of leaks or spills is associated with this AST.
- Two 275-gallon ASTs of unknown content (if any) were located along the northern face of Building 123; one 275-gallon AST was located along the east face of Building 123. All three tanks were in poor condition (corroded). Staining and stressed vegetation were observed around the base of the 'east' tank.
